1. Report No. SSRP-2001/25	2. Government Accession No.	3. Recipient's Catalog No.	
4. Title and Subtitle SEISMIC DESIGN AND PERFORMANCE OF PRECAST CONCRETE SEGMENTAL BRIDGE COLUMNS		5. Report Date May 2002

6. Performing Organization Code	
7. Author(s) Joshua T. Hewes and M. J. Nigel Priestley		8. Performing Organization Report No. UCSD / SSRP-2001/25	
9. Performing Organization Name and Address  Department of Structural Engineering School of Engineering University of California, San Diego La Jolla, California 92093-0085		10. Work Unit No. (TRAIS)

This research involved the investigation of the performance of unbonded post-tensioned precast concrete segmental bridge columns under lateral earthquake loading. Two columns with a high aspect ratio and two columns with a low aspect ratio were tested under simulated lateral seismic loading. Steel jackets of different thickness were used to confine the plastic end region at the base of each column. The specimens all contained the same amount of prestressing steel and each was tested twice: the first time with a relatively low initial tendon stress, and the second with a higher initial prestress level. An analytical model describing the c

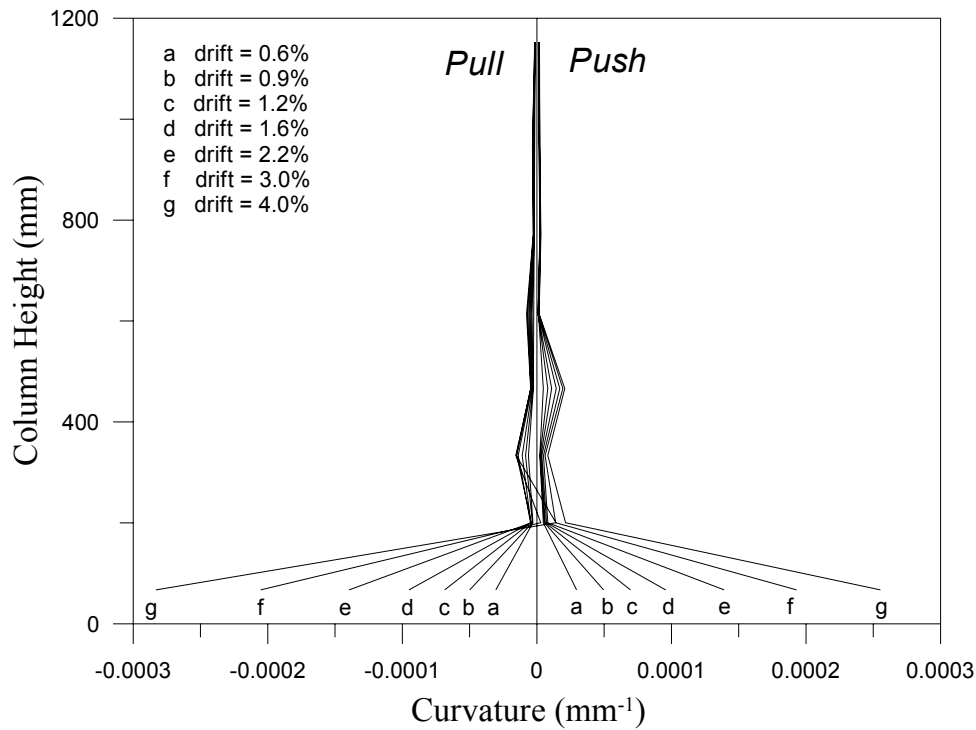
Figure 5.54 JH4 – Test 1 Curvature along column height

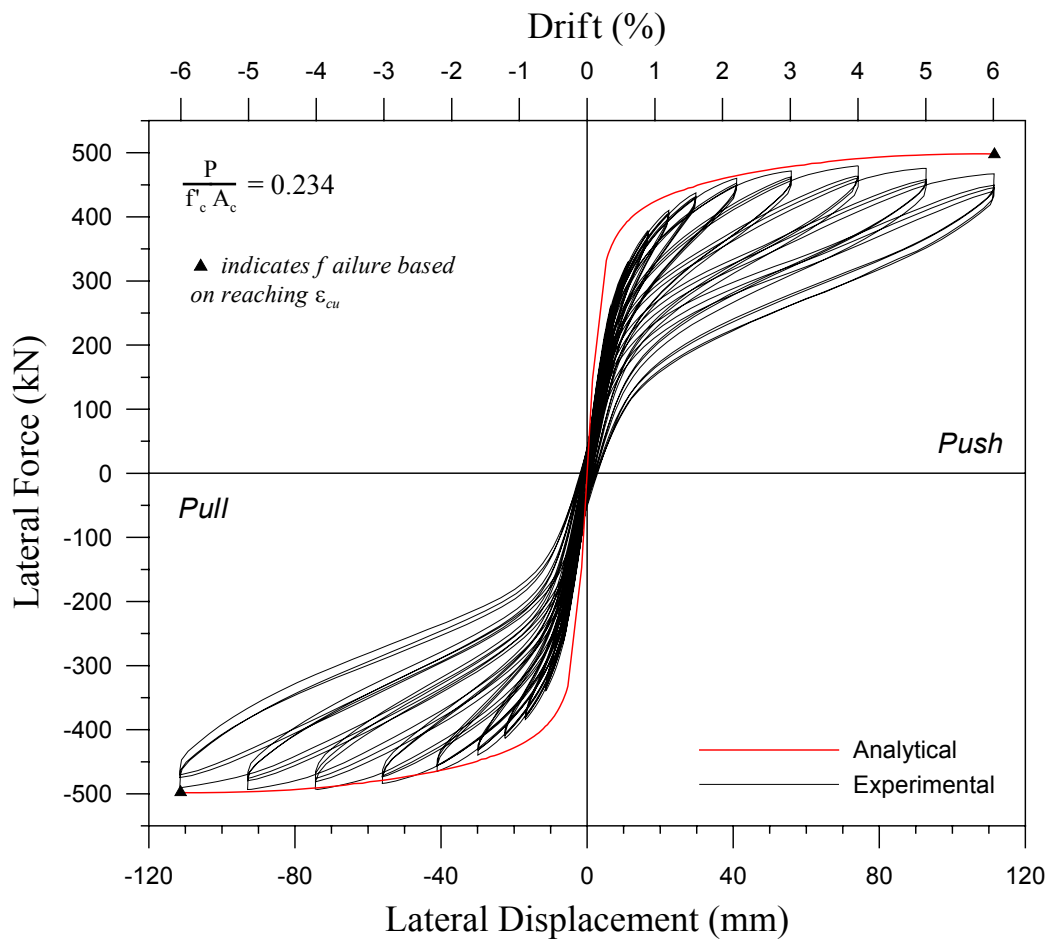
Figure 5.66 JH4 – Test 2 Experimental force-displacement response

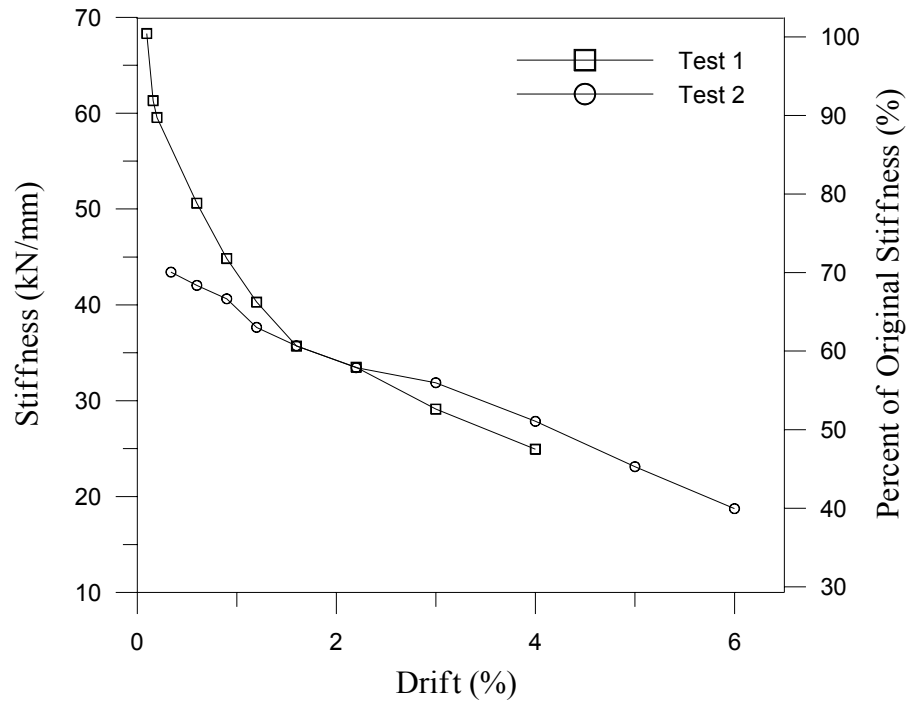
Figure 5.67 JH4 – Test 2 Initial loading stiffness versus drift

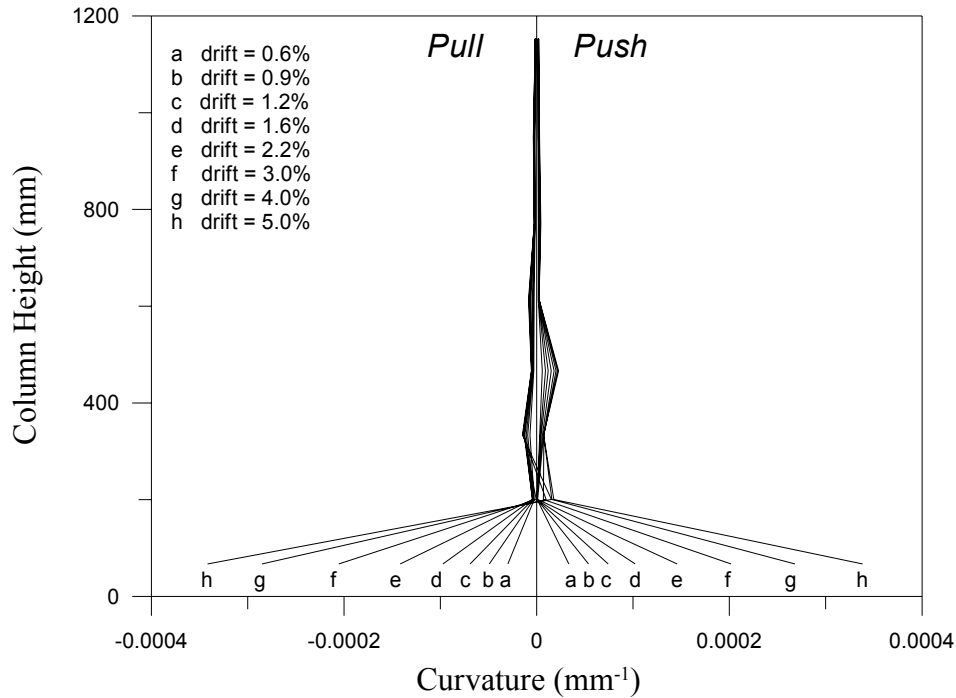
Figure 5.69 JH4 – Test 2 Curvature along column height

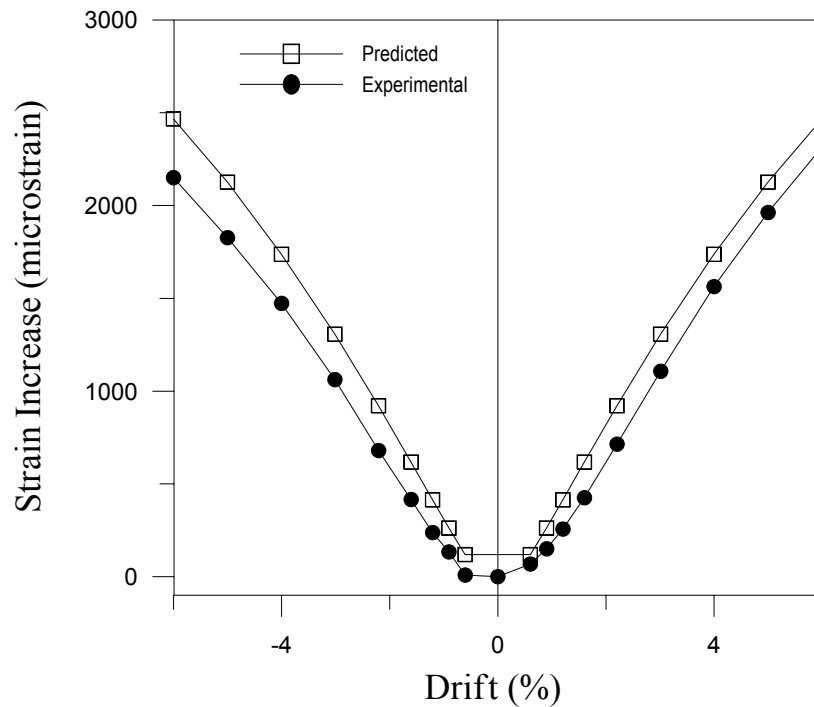
Figure 5.70 JH4 – Test 2 Predicted and experimental tendon strain increase

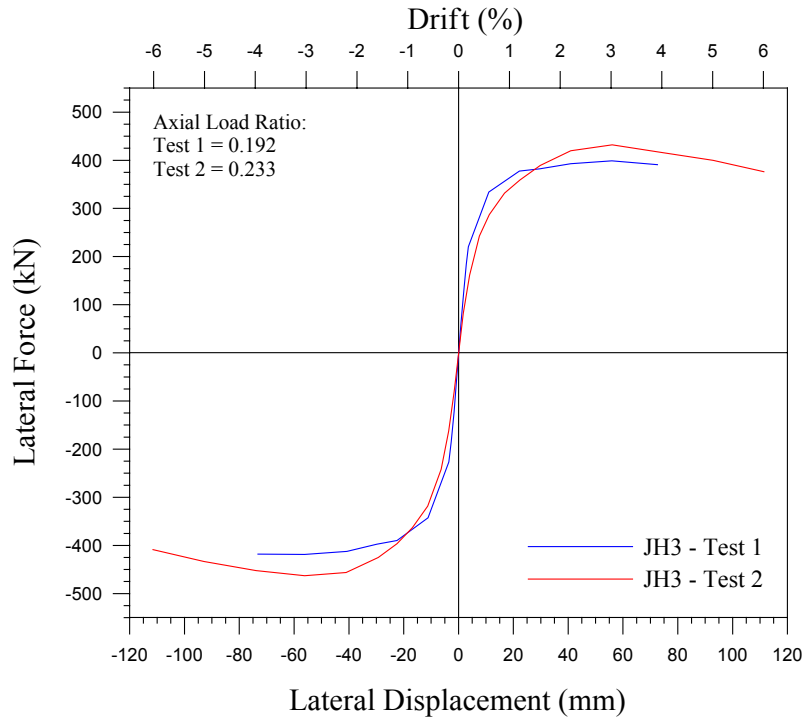
Figure 5.81 JH3 Test 1 and 2 force-displacement response comparison

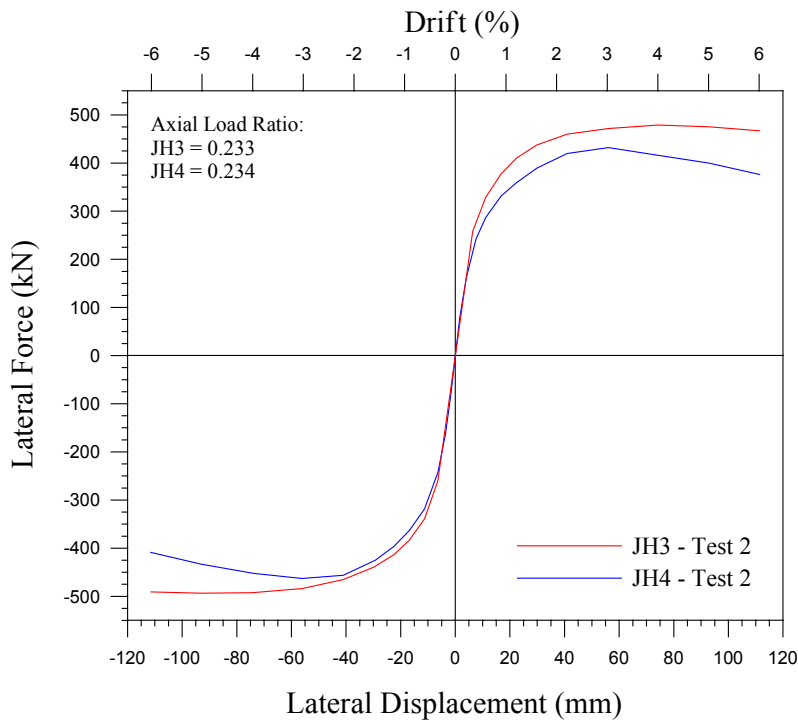
Figure 5.84 JH3 and JH4 Test 2 force-displacement response comparison
